FACE INVESTIGATION

SUBJECT: FARMER DIES WHEN PINNED BETWEEN FRAME AND BUCKET OF A SKID STEER LOADER

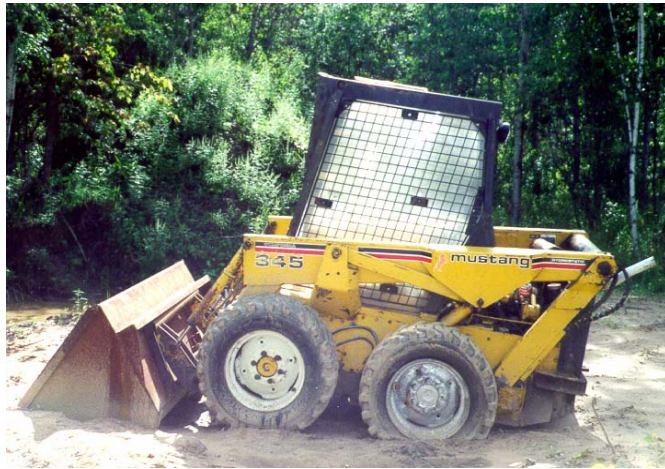
Figure 1. Side View of Skid Steer Loader Involved in Incident

On August 28, 2003, a 41-year-old organic farmer (victim) was pinned between the bucket and the frame of a skid steer loader. (Figure 1.) He was working alone on the loader when the bucket came down and pinned him. His friend was at work and upon her return she was concerned when he did not answer his telephone. She went to his farm and found him. She called EMS.

The victim used the skid steer loader periodically. It was determined that he had used the loader to haul sand from a pile near a pond a short distance away but it is unknown if he hauled sand the day of the incident. It was noted that the rear left side of the skid steer had a flat tire. (Figure 1.) His schedule the day of the incident is unknown, as is the exact time of his death. When his girlfriend left the farm between noon and 12:30 P.M., the victim was leaving the farm to get some gas for the skid steer. The victim had mentioned that it was giving him some trouble and was not running right. It is unknown if the victim elaborated about what might have been wrong with the skid steer. His girlfriend attempted calling him until she went to work at 2:30 P.M. and after work continued to try to contact him by telephone. Around 11:00 P.M. after she got back to the farm, she attempted to locate him and noticed the door on the pole building which was usually locked, was left open. She noticed that another person who was going to come and unload lumber that day had not unloaded it, so it was obvious that he had not come to the farm that afternoon. She then noticed the skid steer and the victim located outside of the pole barn. The victim was pinned between the frame of the loader and the bucket. He was found facing the front of the loader with the bucket down across his back and his feet on the ground. He was possibly working on repairing the skid steer. His friend noted

Recommendation #1: Farmers and employers who operate skid steer loaders should always shut off the loader and lower the bucket before boarding, exiting or performing maintenance repairs.

Discussion: In this case, it is unknown what problem the victim was suspecting with the skid steer. However, when one is working on skid steer loaders with the buckets lowered, the bucket would not be able to fall. To prevent the operator from becoming pinned between the arm or frame and bucket, or under the bucket, the skid steer loader should be shut down and the bucket lowered to the ground before the operator enters or exits the machine. It is unclear if the victim operated the lever from outside the loader or if the hydraulics on the bucket failed. It is unknown if the skid steer was tested for potential problems following the incident.

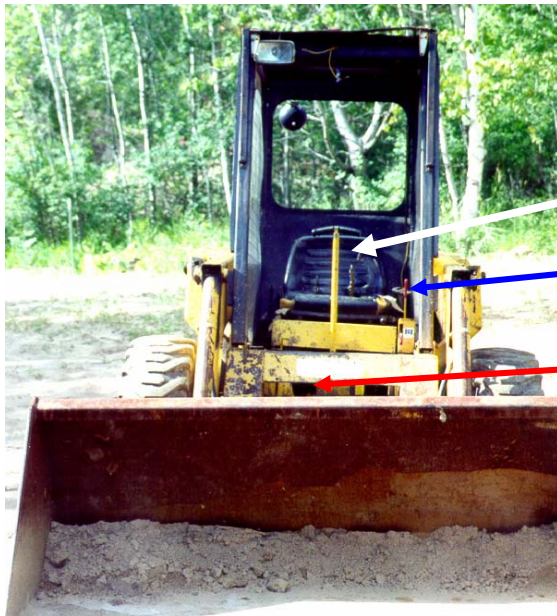
Figure 2. Front View of Skid Steer Involved in Incident

The day of the incident, the victim borrowed the Owatonna 345 Mustang skid steer loader. (Figure 2.)

Steering Control

Loader Lift Arm Control Lever

Location where Victim was Found

The skid loader was equipped with ROPS; however, it is unknown if it had an interlock system that prevented the hydraulic bucket mechanism from being operated when the operator was not in the seat. It was also unknown what safety training the victim had regarding the skid steer.
